Performance Deficiency of Department Store – Case Study

Milan HOLICKÝ
Research Fellow, Czech
Technical University in
Prague, Czech Republic

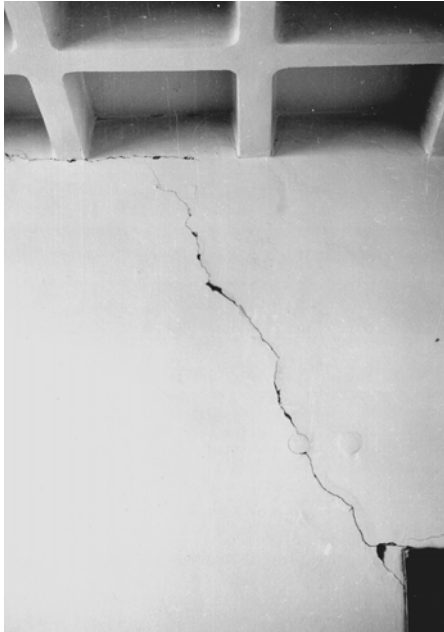
Fig. 4 Partition wall

After few years in service serious performance problems concerning cladding as well as interior non-bearing structures have been observed and analysed [3,4]. The most alarming were perhaps defects appearing in non-bearing structures: cracks of partition walls (see *Fig. 4* and *Fig. 5*) deformed doorframes and buckled shelf stand, which were especially apparent and impressive. Also cladding elements were damaged. Tensile cracks of window pillars were particularly noticeable near to the exterior corners of the building (see *Fig. 6* and *Fig. 7*).

All of the defects of non-bearing structures in the second storey are caused by different deflection of the floor slab (above the first storey) from deflection of the roof slab, primarily due to permanent load and shrinkage. As mentioned above the permanent load of the more flexible roof is by 3 kN/m^2 greater than that of slightly less flexible floor slab. This could lead to considerable differences in midspan deflection (shortening up to 30 mm) as well as cantilever deflection (extension up to 5 mm, at exterior corner up to 10 mm). Also shrinkage may lead to similar mutual differences in slab

Although there were almost no defects apparent on load bearing structural components (except sporadic shear cracks in ribs), it has been decided to close the second storey and to reconstruct most damaged interior partitions and other non-bearing structural components as well as cladding components. Interior partitions including reinforcing steel elements have been separated from the ceiling and new expansion joints have been covered by panel strip. New ties located near window pillars had mutually tied up cantilevered slabs. These measures have been proposed by the designer, even though additionally made analysis show that expected deformations due to temporary load and temperature (as mentioned above) are limited, and in some cases could be admitted without any modification of non-bearing structures.

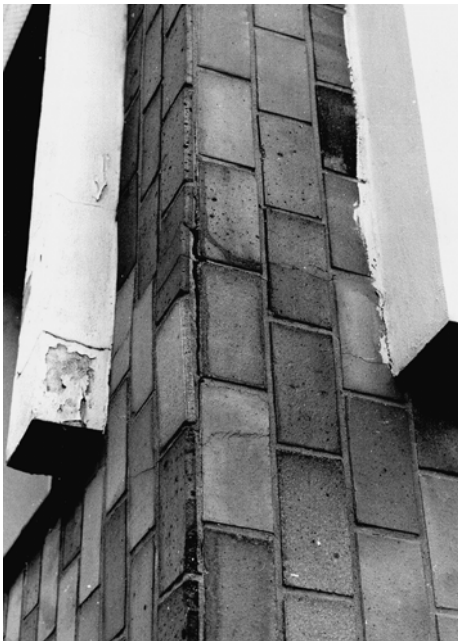
Fig. 6 Façade corner

Another construction fault mentioned above concerns permanent load of the roof slab. Due to actual own weight of the ceiling and roof (slope concrete layers) the permanent load of the slab is by 30 % greater than that assumed in design calculation. However this discrepancy is also due to negligence of some load components in design calculation. Also actual permanent load of the slab above the first storey may be slightly greater than that considered in design. Even though the deformation effects would be considerably lower if the actual load equals the assumed load, many of serviceability defects would anyhow appear. This concerns above all cracks in cladding elements particularly at the exterior corners of two-way cantilevered slabs.
