Second International Conference on Forensic Engineering, ICE London, UK, 2001, to be published.

Structural failure and assessment of a department store

DR. M. HOLICKÝ

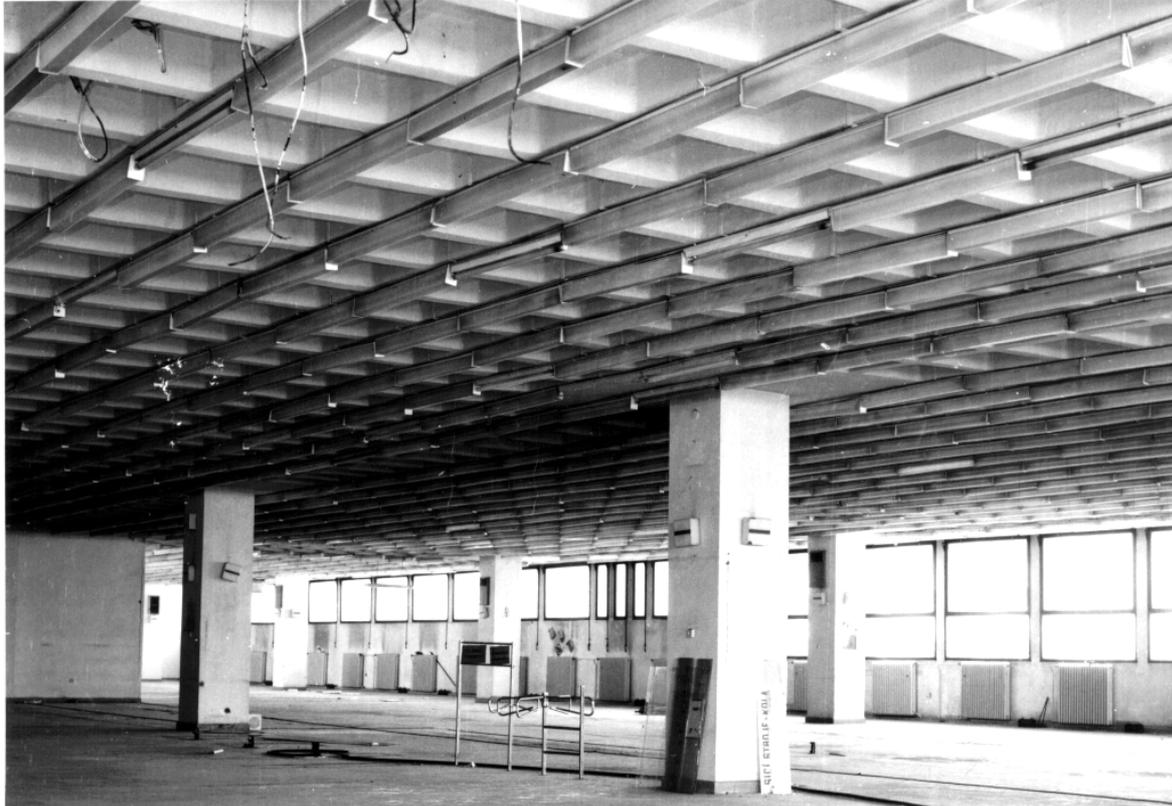
The plan view dimensions of the building are 78×53 m. The load-bearing structure consists of reinforced concrete double ribbed slabs of the total thickness 0.45 m supported directly by columns of the cross section 0.5×0.5 m or 0.7×0.7 m located within span distances 12×12 m (see Figure1). The slabs are provided by in-depth heads, 1.65×1.65 m (at the edge columns) and 3.35×3.35 m (at the interior columns), where the coffer ceiling is replaced by solid slab. In the remaining part of the slab, the ribs of the cross section 0.18×0.38 m support a thin plate (of the thickness 0.07 m and interior spans 0.8×0.8 m). Equivalent thickness of a solid slab having the same rigidity would be 0.34 m only, which indicates that the stiffness of the slab is very low. Moreover, slabs above the first and second storey cantilever out beyond edge columns by 3 m.

Figure 1. Internal view of the structure

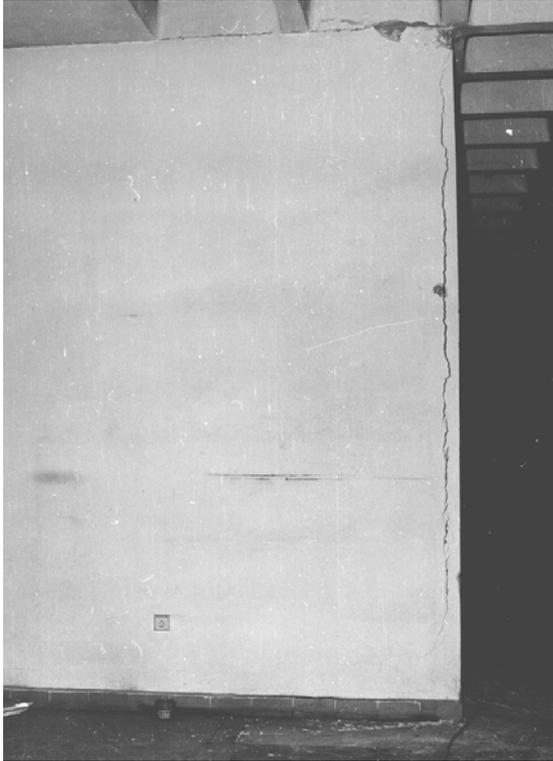
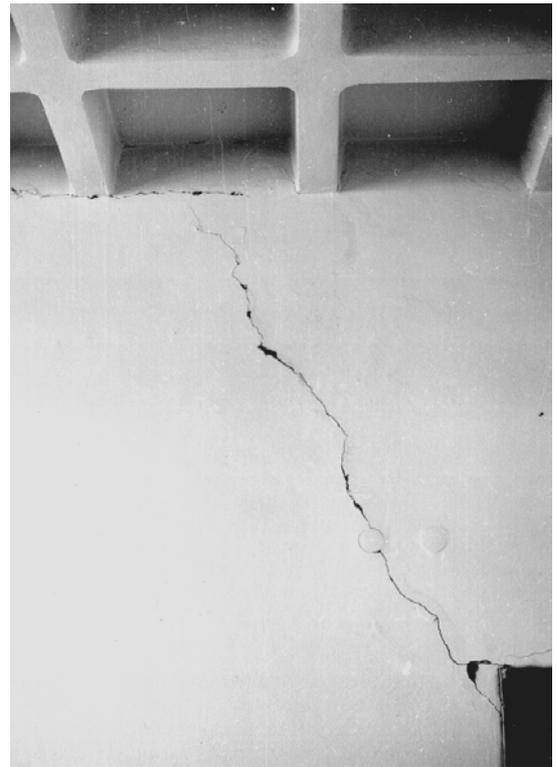
After few years in service serious performance problems concerning cladding as well as interior non-bearing structures have been observed and analysed [3,4]. The most alarming were perhaps the defects appearing in the non-bearing structures: cracks of partition walls (see Figure 2 and 3).

Figure 2. Partition wall

Figure 3. Partition wall

All of the defects of non-bearing structures in the first floor are caused by differential deflections of the floor slab (above the ground floor) and of the roof slab, primarily due to permanent load and shrinkage. As mentioned above the permanent load of the more flexible roof is by 3 kN/m^2 greater than that of the slightly less flexible floor slab. This could lead to considerable differences in the midspan deflection (shortening up to 30 mm) as well as cantilever deflection (extension up to 5 mm, at exterior corner up to 10 mm). Also shrinkage may lead to similar mutual differences in slab deflections; midspan shortening and cantilever extension may reach 5 mm (extension at exterior corners may be 10 mm).

Although there were almost no defects apparent on the load bearing structure (except sporadic shear cracks in ribs), it was decided to close the first floor and to reconstruct damaged interior partitions and other non-bearing structural components as well as the cladding components. Interior partitions including steel elements have been separated from the ceiling and new movement joints have been covered by panel strip. New ties located near window pillars have mutually tied up the cantilevered slabs. These measures were proposed by the designer, even though an additional analysis shows that the expected deformations due to temporary load and temperature (as mentioned above) are limited, and in some cases could be admitted without any modification of the non-load-bearing structures.

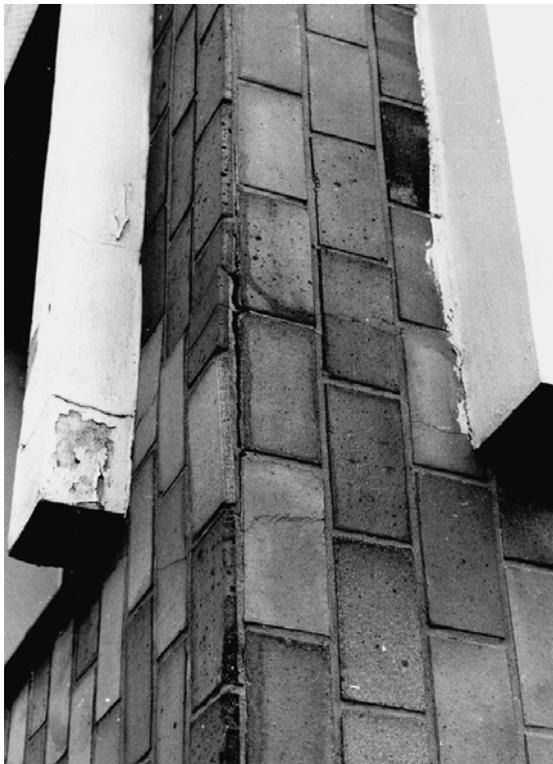
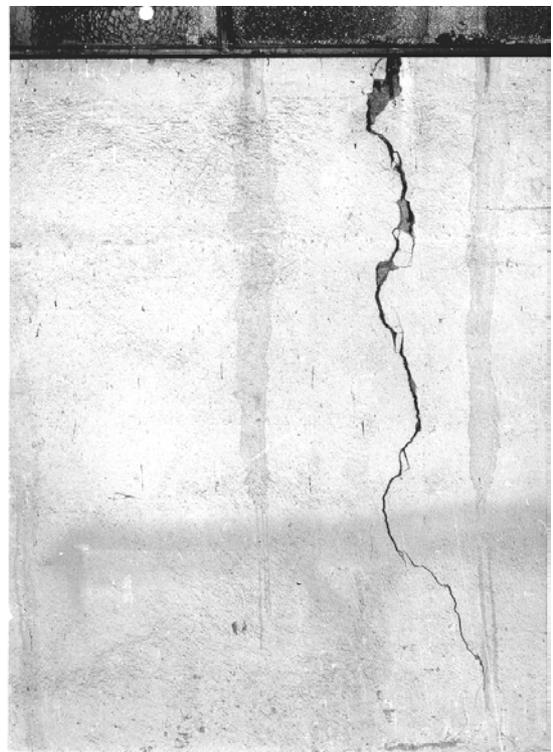
Figure 4. Façade corner

Figure 5. Façade wall

Tensile cracks of the window pillars and cladding elements were particularly noticeable near the exterior corners of the building (see Figure 4 and 5). Also, the deformed doorframes and a buckled shelf stand were visible and impressive. There were also sporadic shear cracks in the slab ribs close to the hidden column heads, however, they were mostly near construction joints. These cracks, which were of smaller importance for the overall damage assessment of the building, were the only detected defects of the load bearing structure.

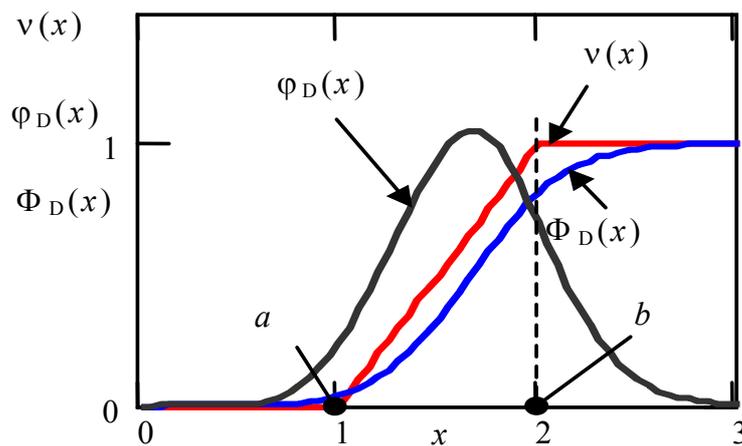
Figure 6. Perception model

where K is the normalising factor to normalise $\Phi_D(x)$ into the interval from 0 to 1 and ξ is the integration variable. The cumulative damage $\Phi_D(x)$ and a corresponding density function $\phi_D(x)$, shown in Figure 6 for $a = 1$, $b = 2$ and $s = 0.3$, can be considered as generalised probabilistic models (involving economic aspects). The cumulative damage $\Phi_D(x)$ can be used to specify in a rational way the required serviceability constrains [2,3].

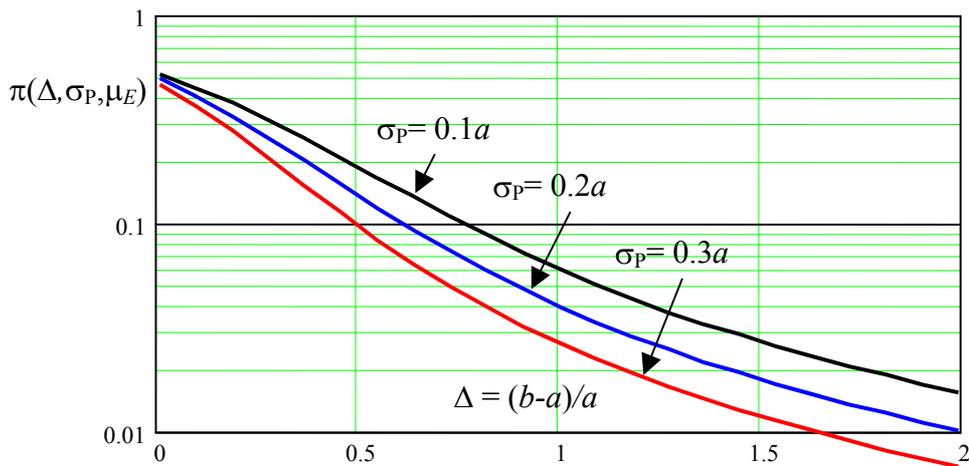
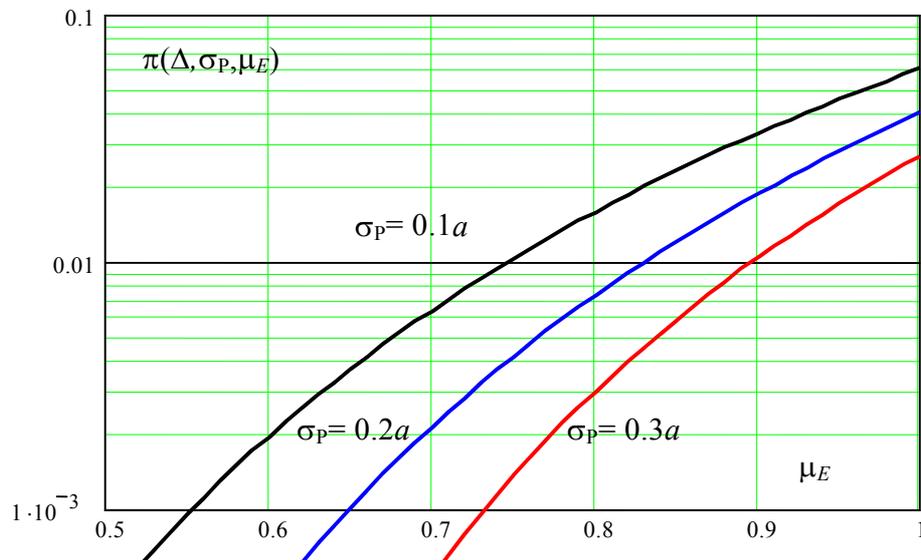
Here $\varphi_E(x)$ is the probability density function of E . Gamma distribution having the mean μ_E is assumed. The mean μ_E equal to the lower limit of the transition region a , $\mu_E = a$, and the standard deviation $\sigma_E = 0.2\mu_E$ (the coefficient of variation 0.2) is assumed in the example shown in Figure 7, where the expected perception level $\pi(\Delta, \sigma_P, \mu_E)$ is indicated as a function of the ratio $\Delta = (b-a)/a$ for selected σ_P . Figure 8 shows $\pi(\Delta, \sigma_P, \mu_E)$ versus μ_E .

Figure 7. Perception level $\pi(\Delta, \sigma_P, \mu_E)$ for $\mu_E = a$.

Figure 8. Perception level $\pi(\Delta, \sigma_P, \mu_E)$ for $\Delta = 1$.

It follows from Figure 7 and 8 that the expected damage (perception) level $\pi(\Delta, \sigma_P, \mu_E)$ is strongly dependent on both the ratio $\Delta = (b-a)/a$ and the mean μ_E , which may further depend

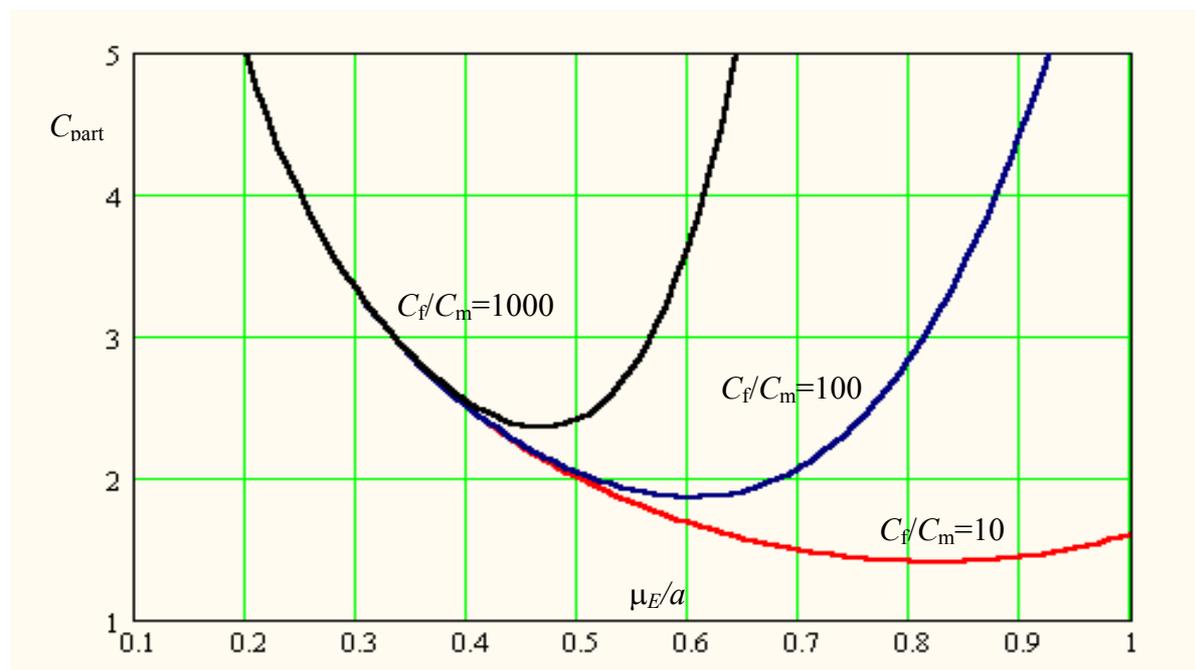
is the minimum, where $C_{part} = (C_{tot} - C_0)/C_f$. Figure 9 shows the partial cost C_{part} for the following parameters: $(b-a)/a=1$, $\sigma_P=0.3a$, $\sigma_E=0.2\mu_E$.

Figure 9. The partial cost C_{part} versus μ_E/a for $\Delta = (b-a)/a=1$, $\sigma_P=0.3a$, $\sigma_E=0.2\mu_E$

It follows from Figure 9 that the optimum mean μ_E may be expected from $0.5a$ to $0.8a$. However, for extremely high cost of failure C_f greater than $1000 C_m$ the optimum mean will be lower than $0.5a$. Obviously, depending on the assumed cost ratio C_f/C_m the optimum (the most suitable) mean μ_E of the load effect E may considerably vary. A further analysis is certainly needed in order to take into account various parameters and expected consequences, including life safety.
