# Structural failure and assessment of department store

Milan Holický

Klokner Institute of the Czech Technical University in Prague

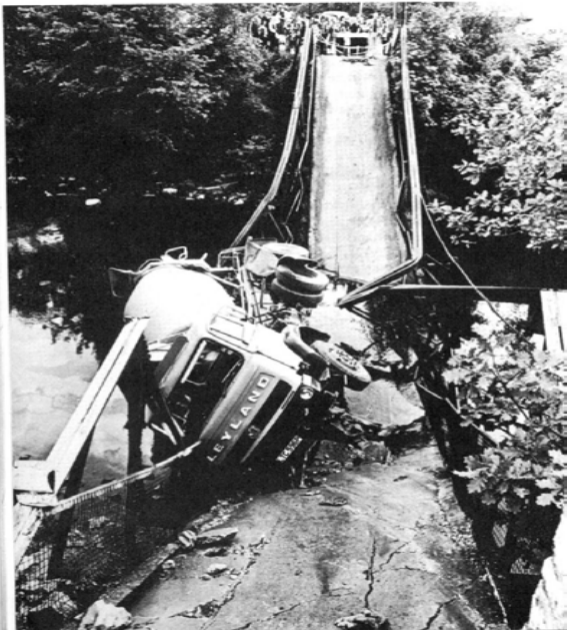
Damaged  
caused by  
an overloaded  
lorry  
on a bridge

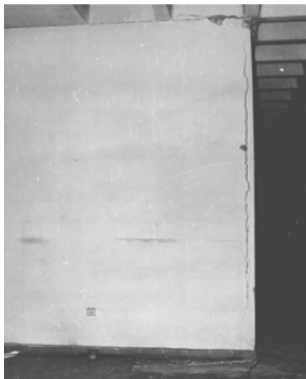
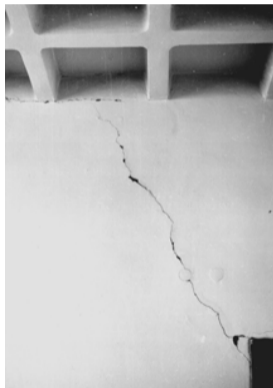
# Damage of partition walls

- partition walls were separated from ceilings,
- cantilevers were braced by partially prestressed ties.

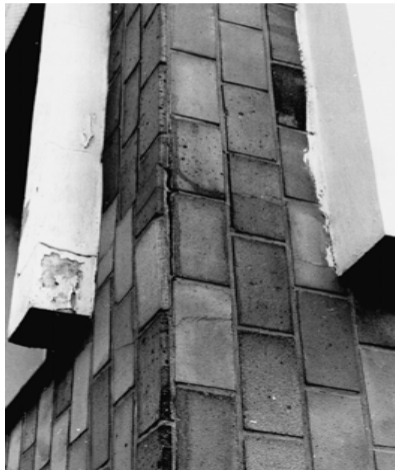
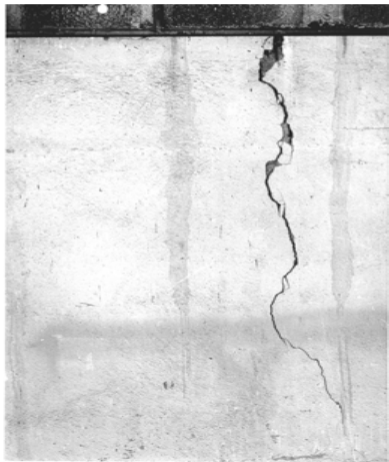
# Damage of façade
