Performance Deficiency of Department Store – Case Study

Milan HOLICKÝ
Research Fellow, Czech
Technical University in
Prague, Czech Republic

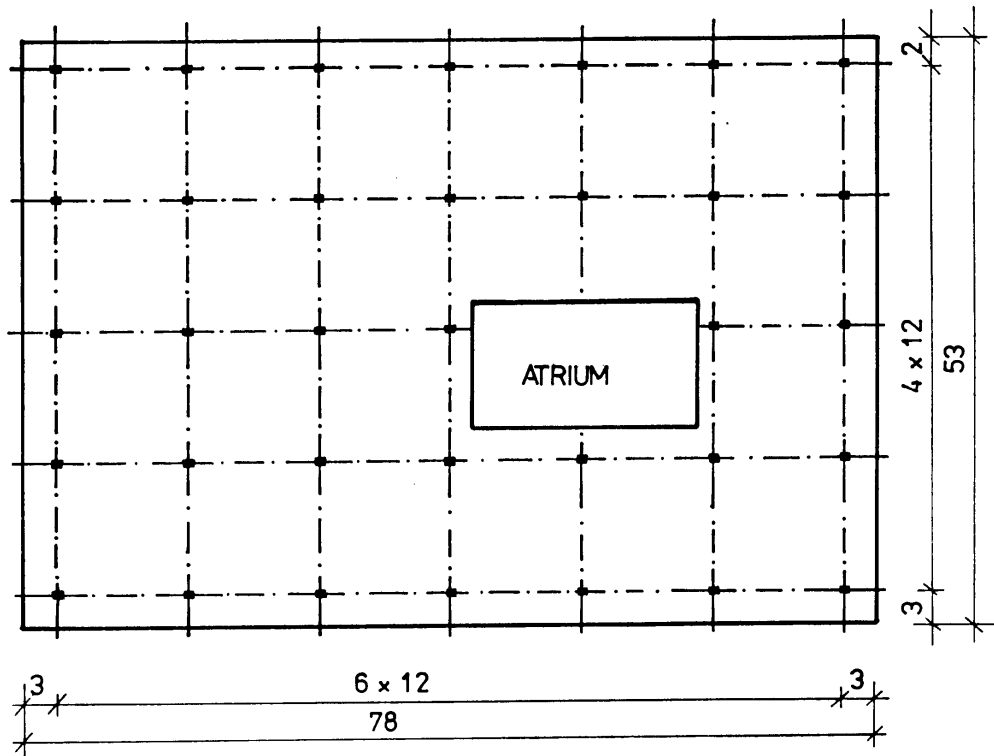
Fig. 1 Plan view of the department store

Plan view of the building of the gross area 78×53 m is schematically indicated in *Fig. 1*. Load-bearing structure consists of reinforced concrete double ribbed slabs of the total thickness 0,45 m (see *Fig. 2*) supported directly on columns of the cross section $0,5 \times 0,5$ m or $0,7 \times 0,7$ m located within span distances 12×12 m (see also *Fig. 3*). The slabs are provided by hidden heads of the plan view dimensions $1,65 \times 1,65$ m (at the edge columns) and $3,35 \times 3,35$ m (at the interior

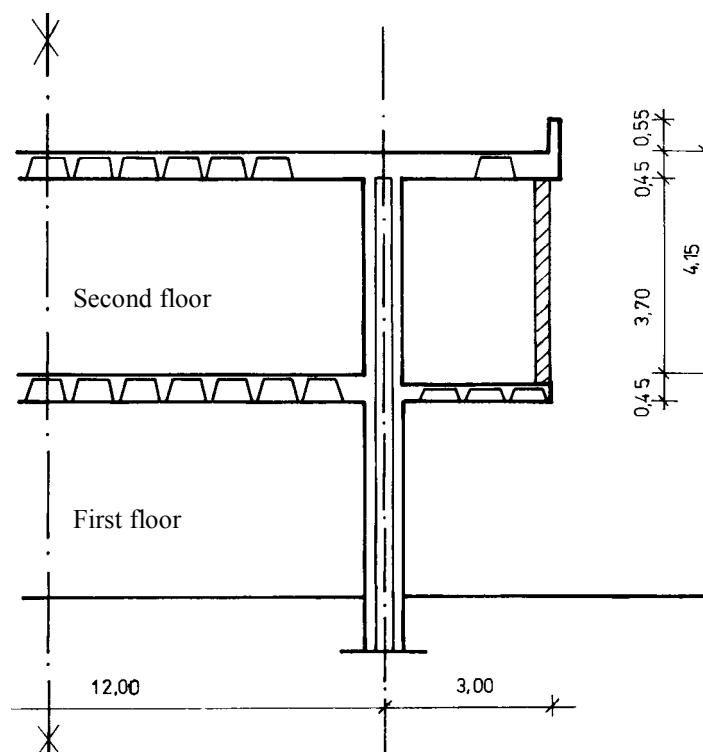
Fig. 2 Section view of the department store

0,8 × 0,8 m). Equivalent thickness of the solid slab having the same rigidity would be 0,34 m only, which indicates that stiffness of the slab is very low. Moreover, slabs above the first and second storey cantilever out beyond edge columns by 3 m.
